ATTACHMENT 7

PICTORIAL REVIEW OF THE REMEDIATION ACTIVITY

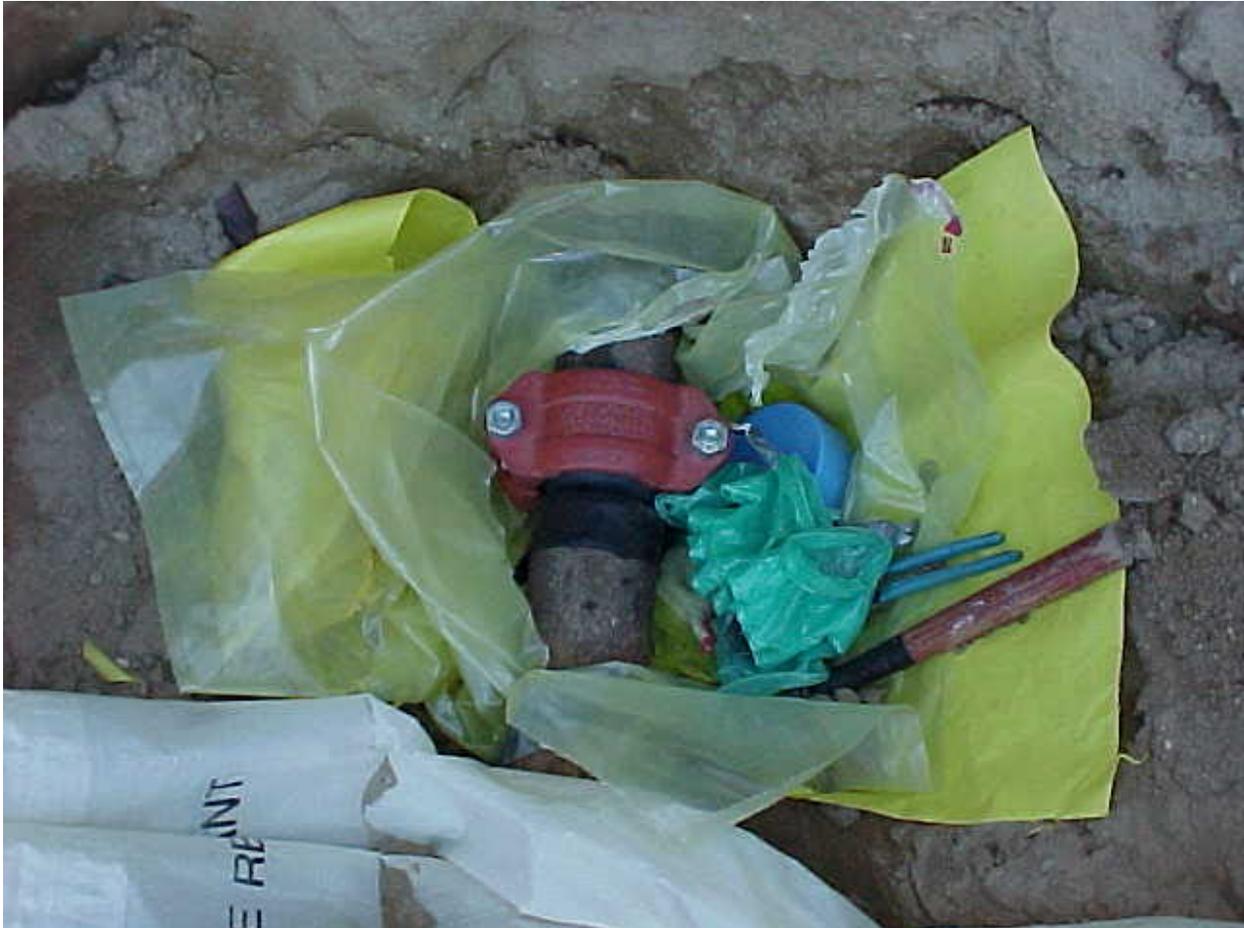
Photo 5. Isolation of the stack carbon steel drain line at the Fan House Building 704 North wall. Contamination found under the piping at the first joint was remediated to background levels within two feet under the drain line joint.

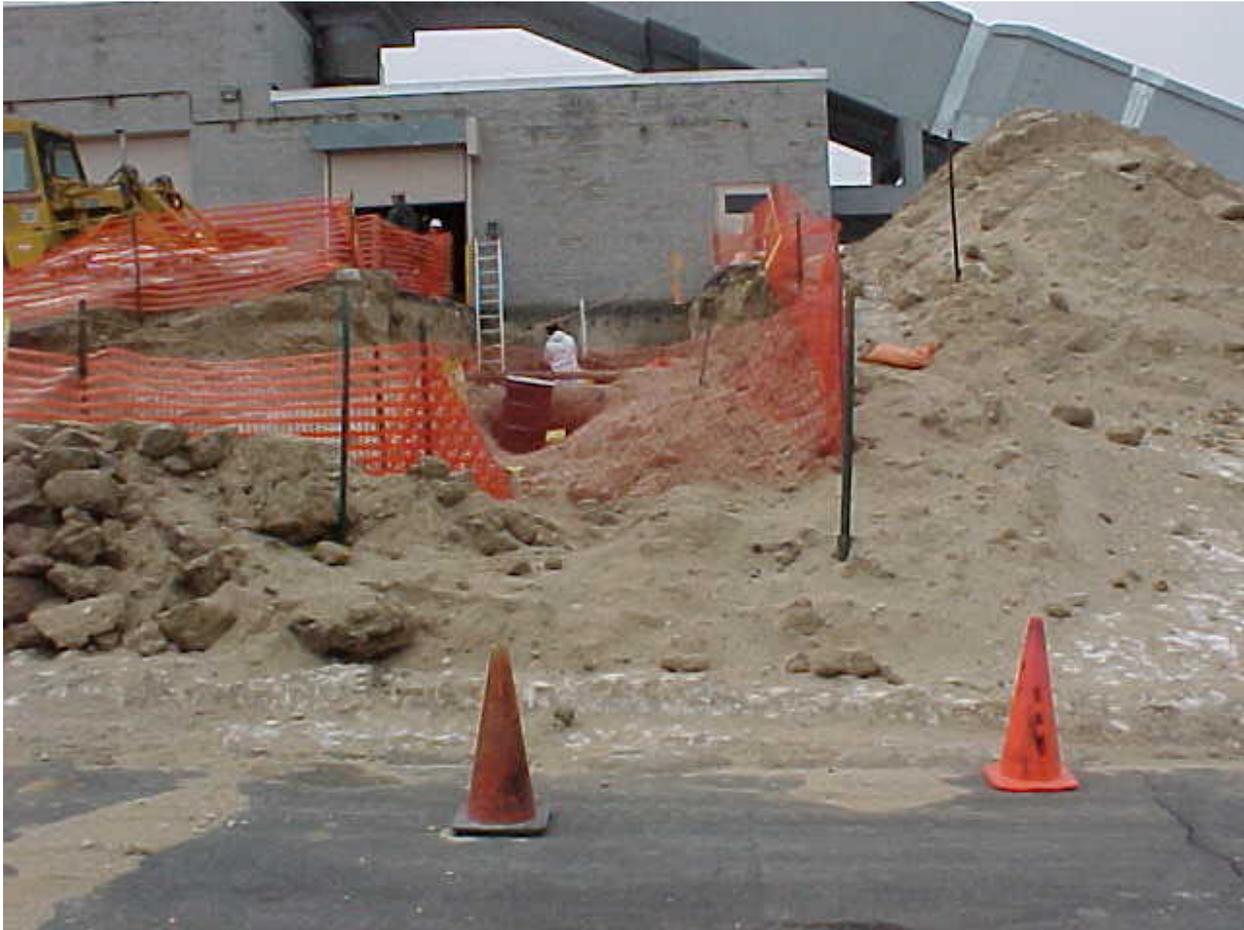
Photo 6. Drain line excavation looking south towards the Fan House Building 704 from the road. Large excavation for the 4-inch-diameter drain line.

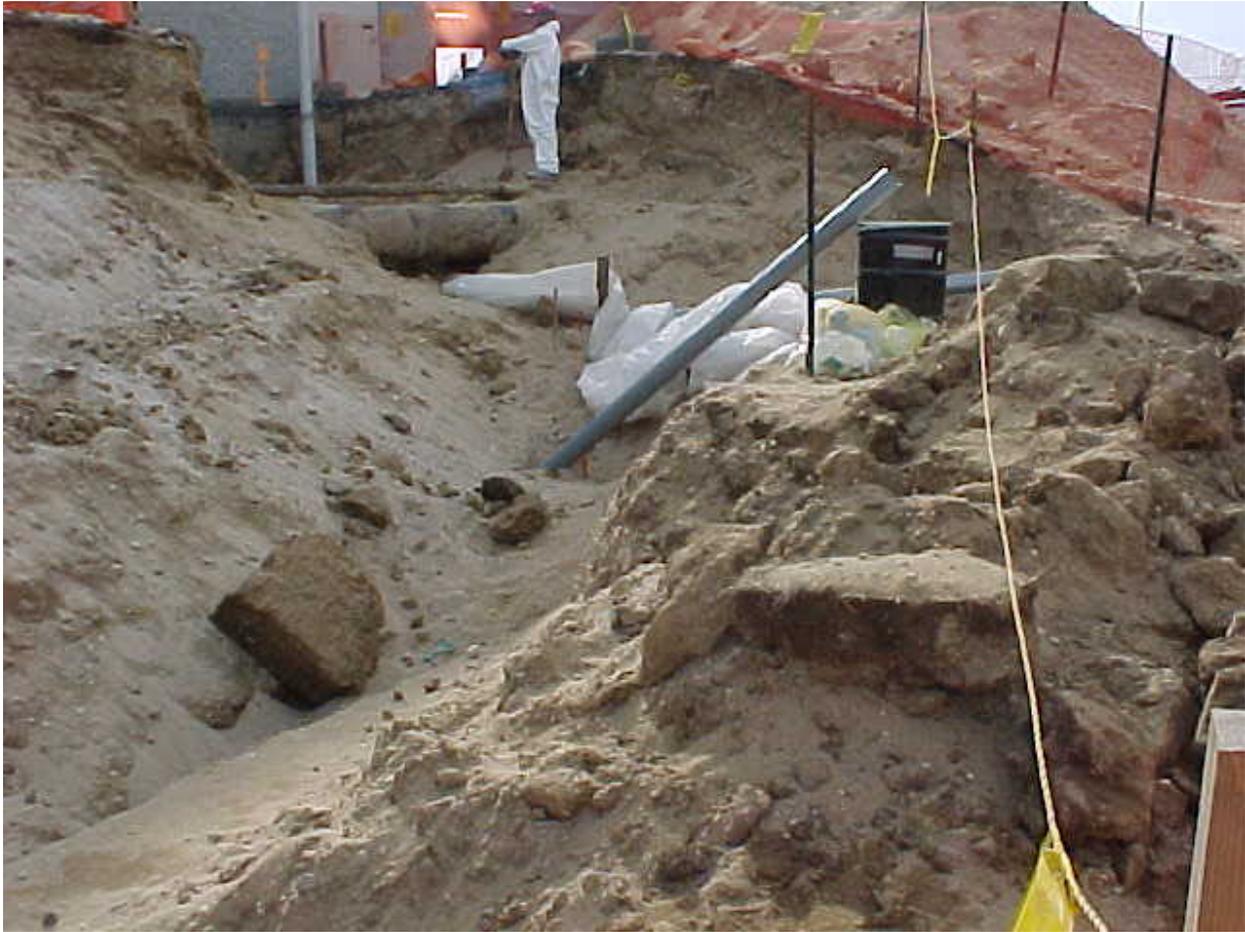
Photo 8. Installation of the gray 6-inch-diameter sample piping at each pipe joint location along the piping run.

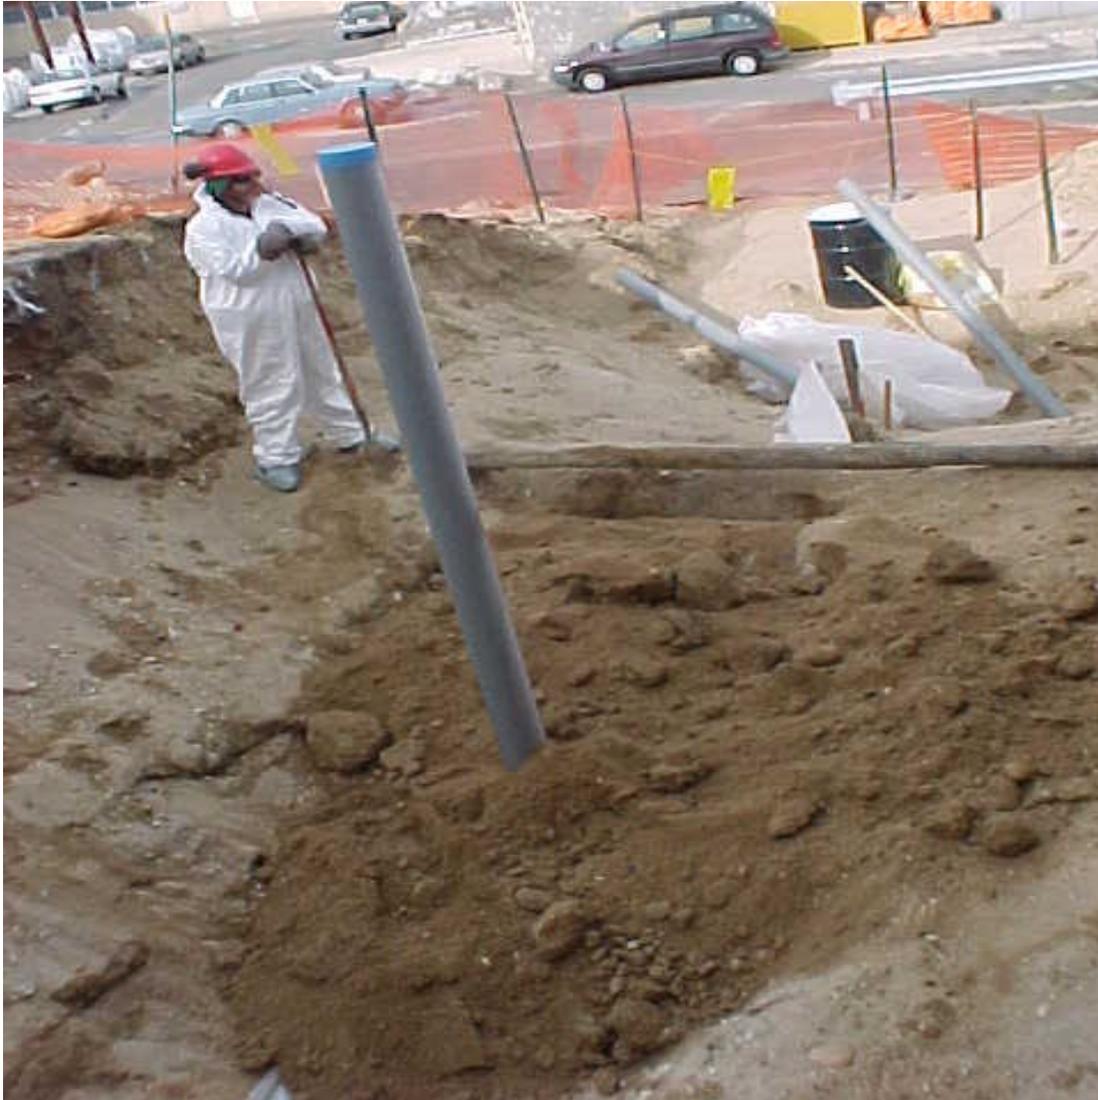
Photo 9. Close-up of sample tubing installed at each pipe joint. This permits reproducible sampling locations yet allows for the backfilling of the excavation.

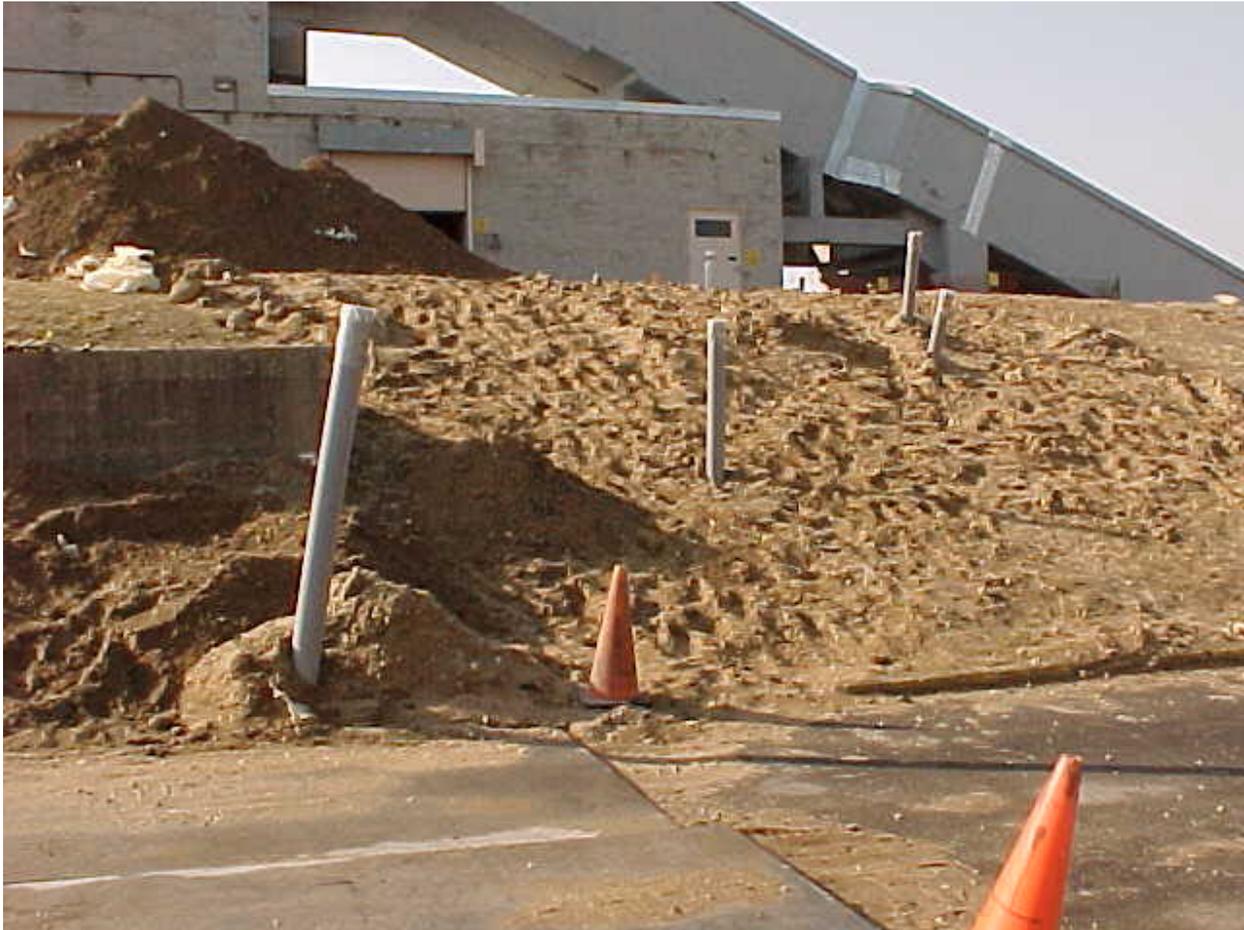
Photo 13. Looking south from the Pile Fan Sump. Drain line excavation restored with sample tubes extending from each pipe joint location to allow sample location reproducibility.

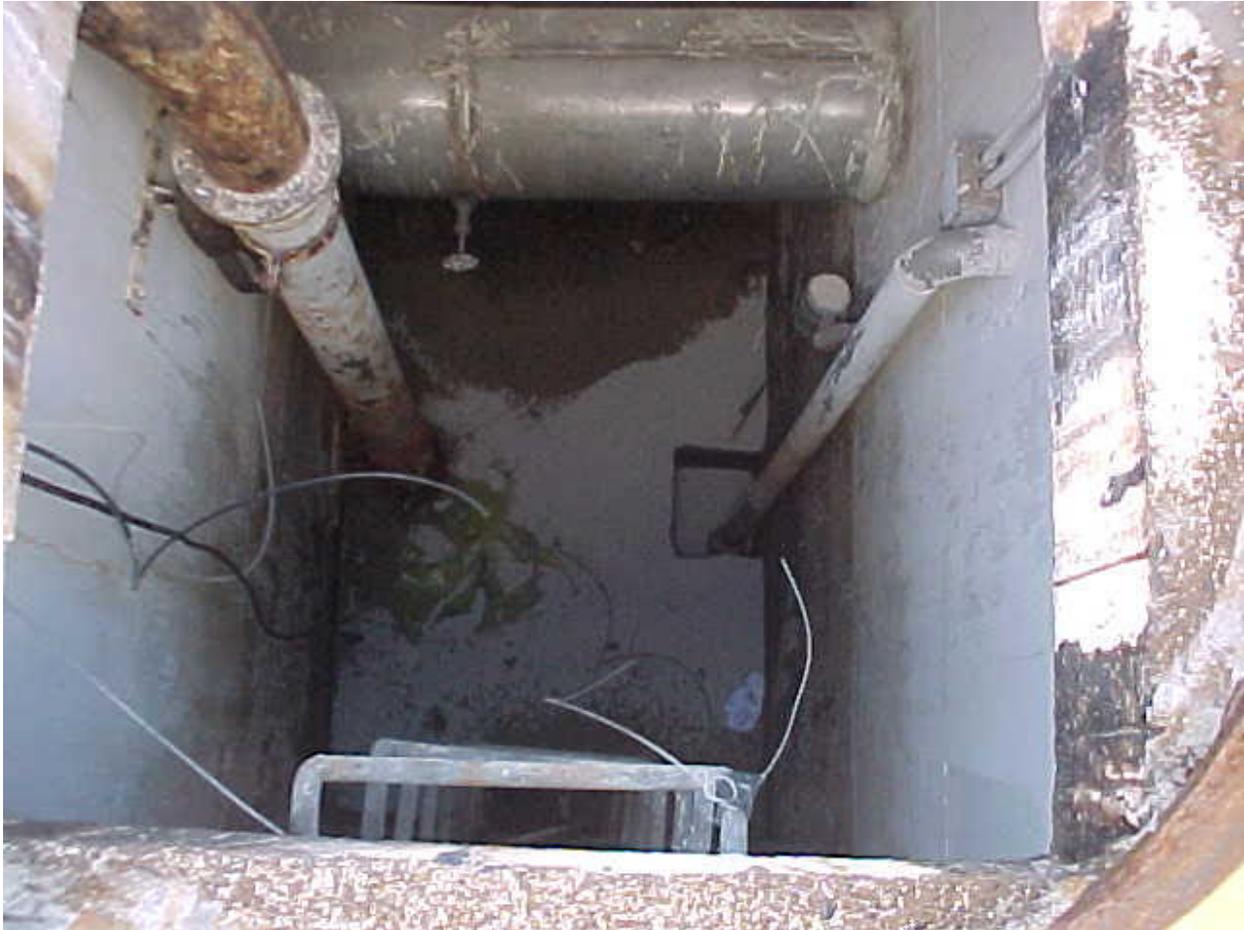
Photo 14. Pile Fan Sump interior after removing sludge in preparation for removal. At top, west, 14-inch-diameter stainless-steel acid fume hood ventilation line low point drain in the Pile Fan Sump. At left, south 4-inch-diameter cast-iron drain line. At right, north, 2-inch-diameter stainless-steel Pile Fan Sump discharge line to Building 801 holding tanks.

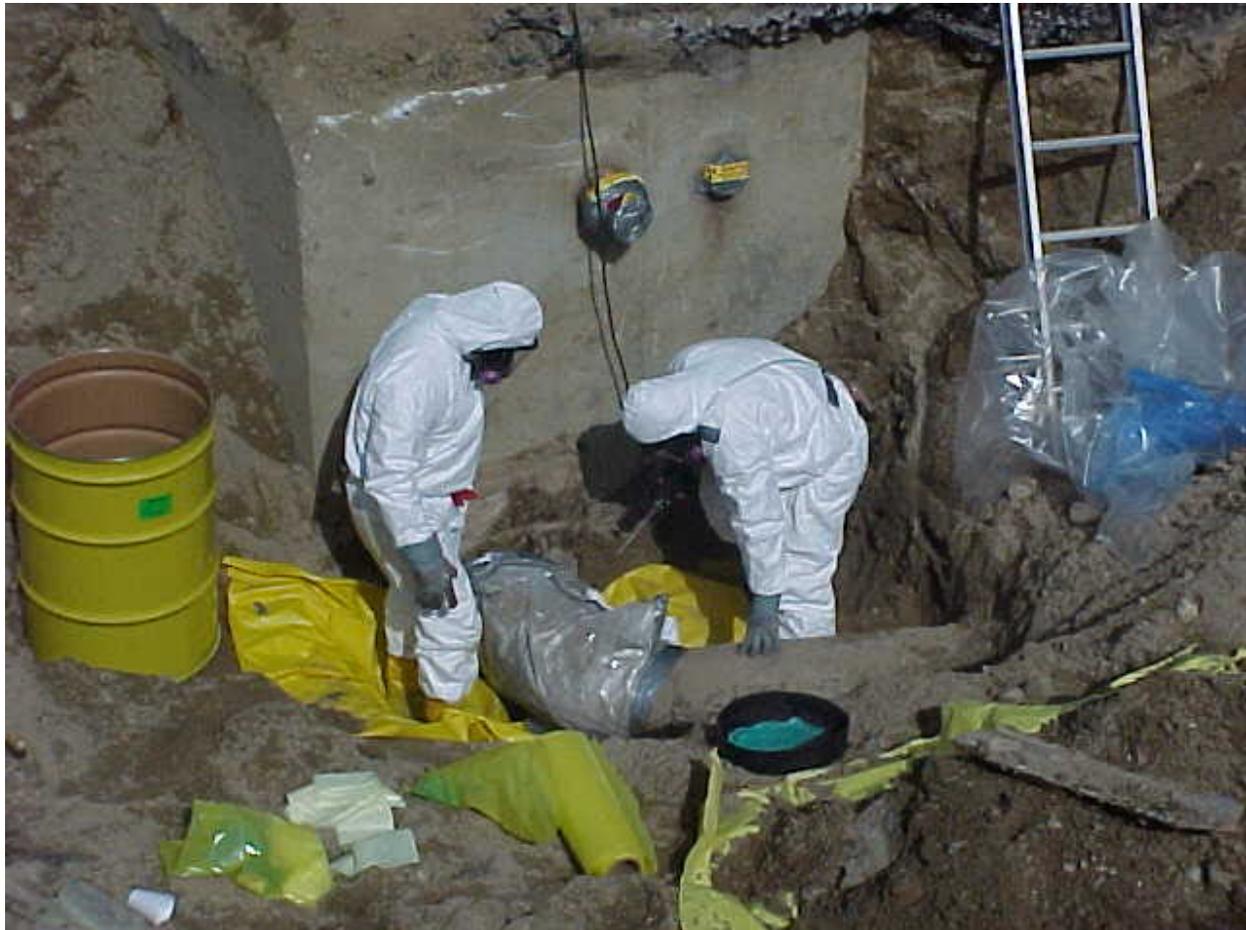
Photo 17. The south wall of the Pile Fan Sump. Preparations being made to cut the 14-inch-diameter stainless-steel acid fume hood ventilation line at the Pile Fan Sump wall and just past the pipe elbow.

The highest levels of Cs-137 contamination were found below this pipe at the Pile Fan Sump wall.

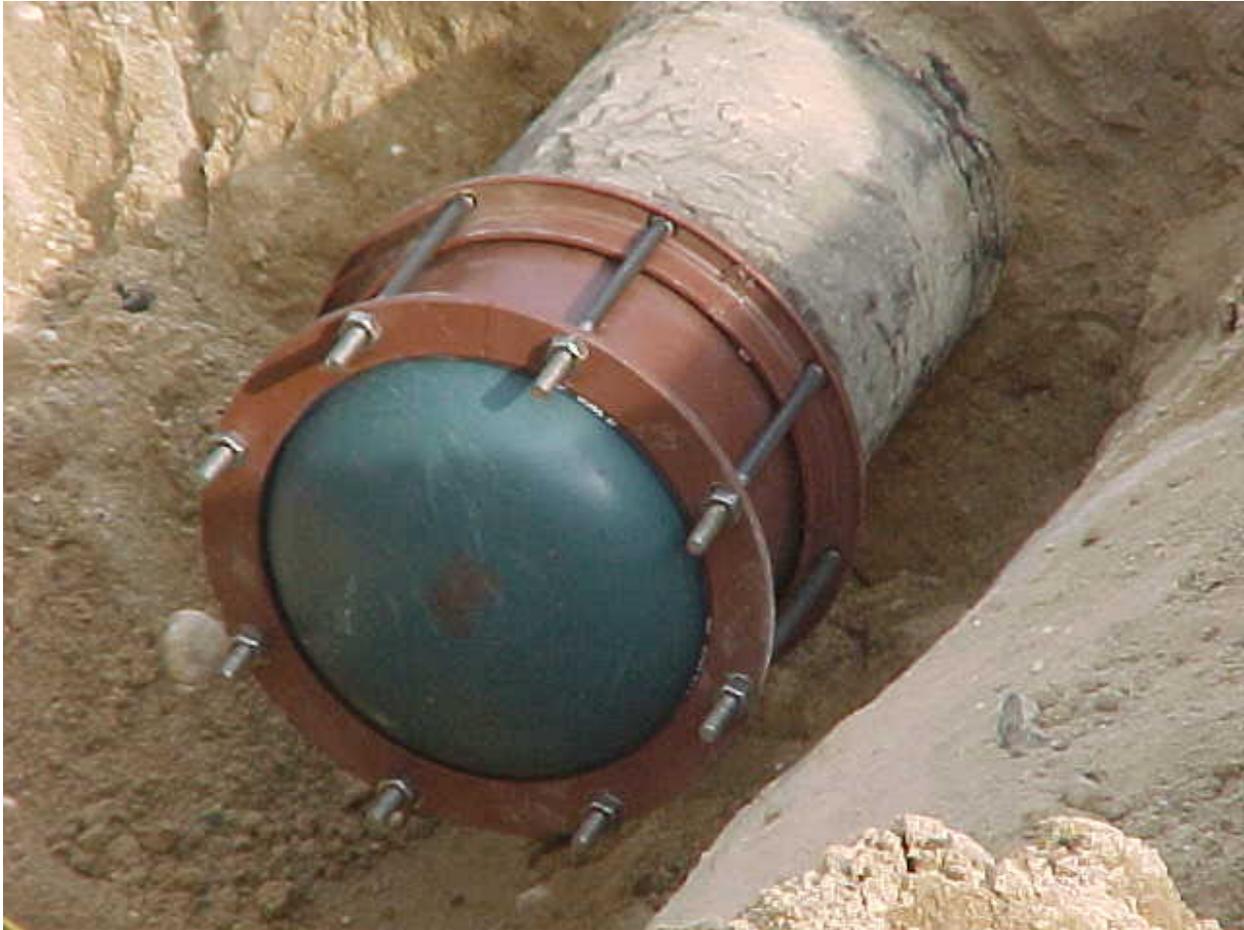
Photo 19. Cap installed on the 14-inch-diameter stainless-steel acid fume hood ventilation line. The physical condition of the line is very good.

Note the large line on the right. This is the large concrete normal ventilation line from building 801 to the Building 801 Fan House Building 802.

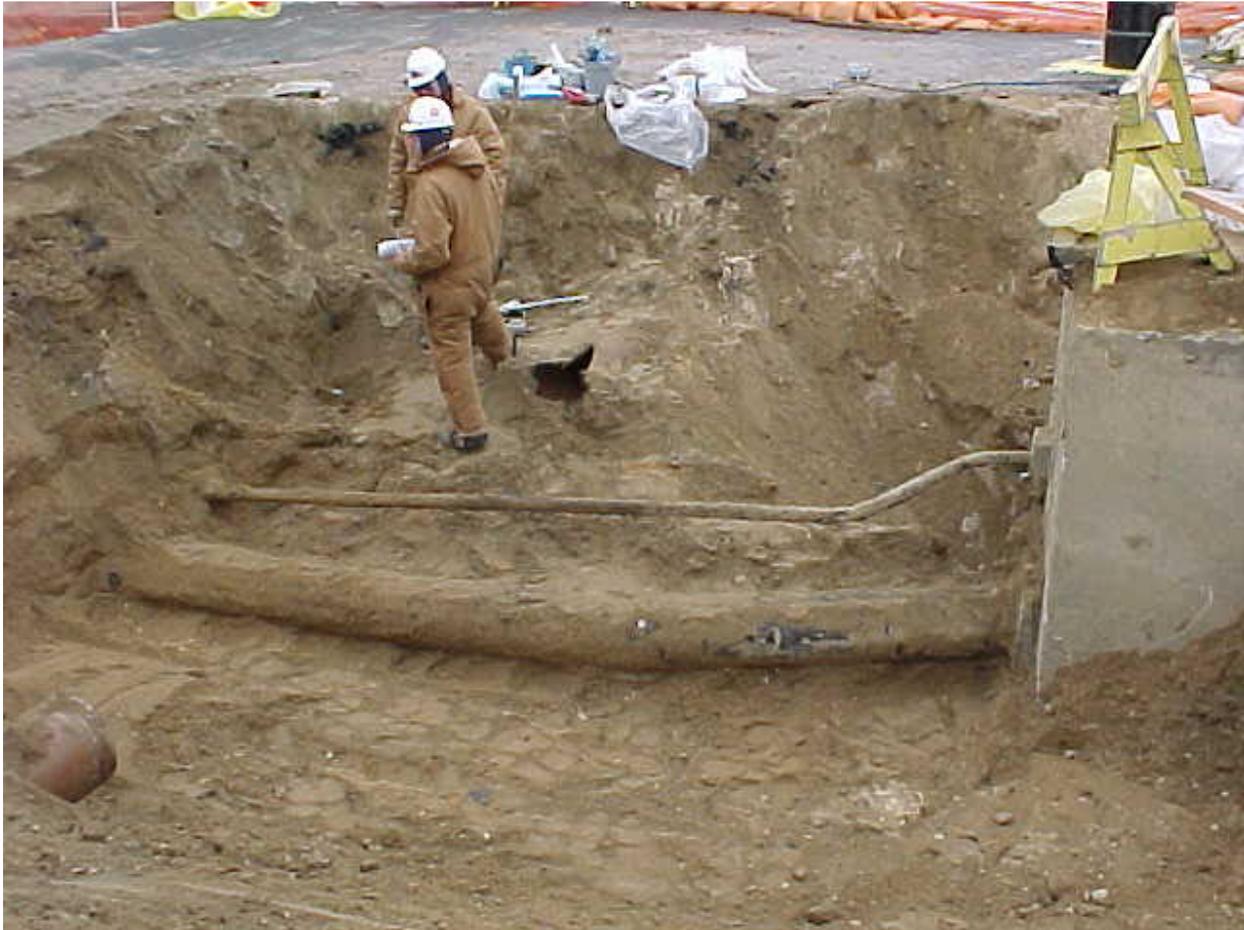
Photo 20. Pile Fan Sump looking east. Preparation to remove the piping from the Pile Fan Sump north to Building 801.

The 14" and the 2" piping are stainless steel with welded joints. No contamination was found under or around these pipes except at the Pile Fan Sump wall penetration.

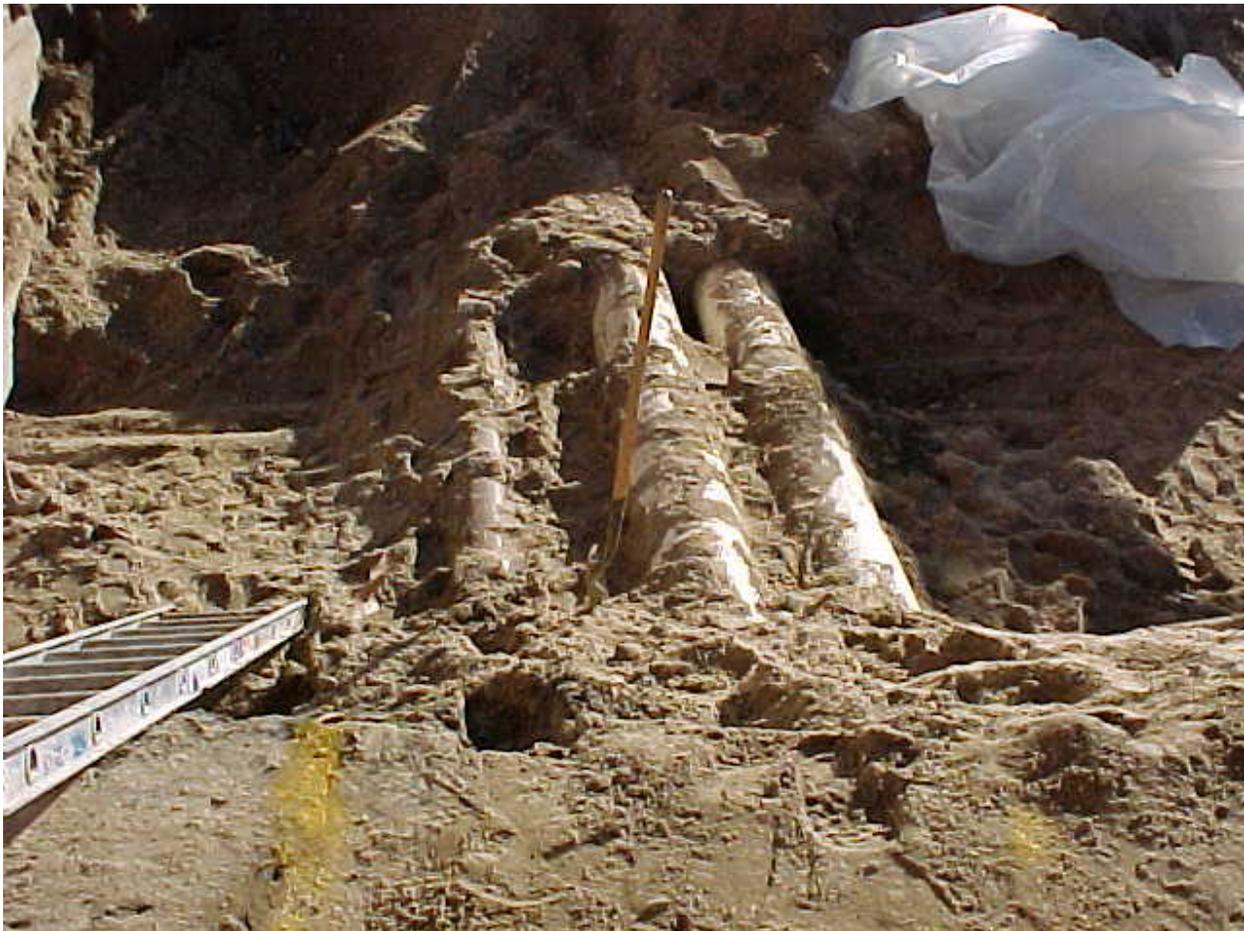
Photo 25. Excavation being performed manually to uncover the last sections of piping to be removed from the Pile Fan Sump to Building 801.

The piping running from the west to the east, bottom of the picture to the top are water lines that are in service.

The piping to be removed is running from the north to the south, from the left of the picture to the right.

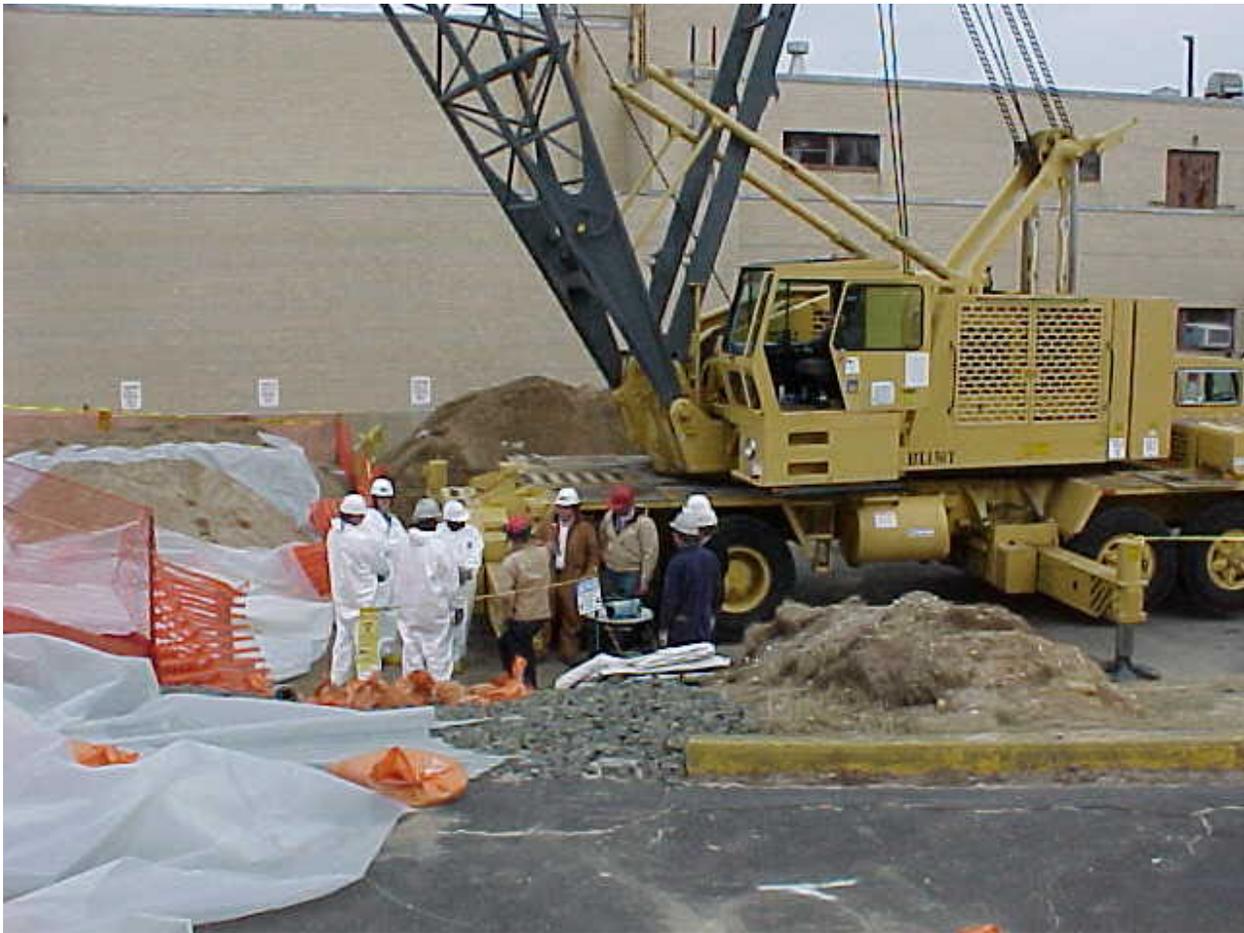
Photo 27. Pre-job briefing just prior to removing the Pile Fan Sump in a single crane lift, approximately 27,000 pounds.

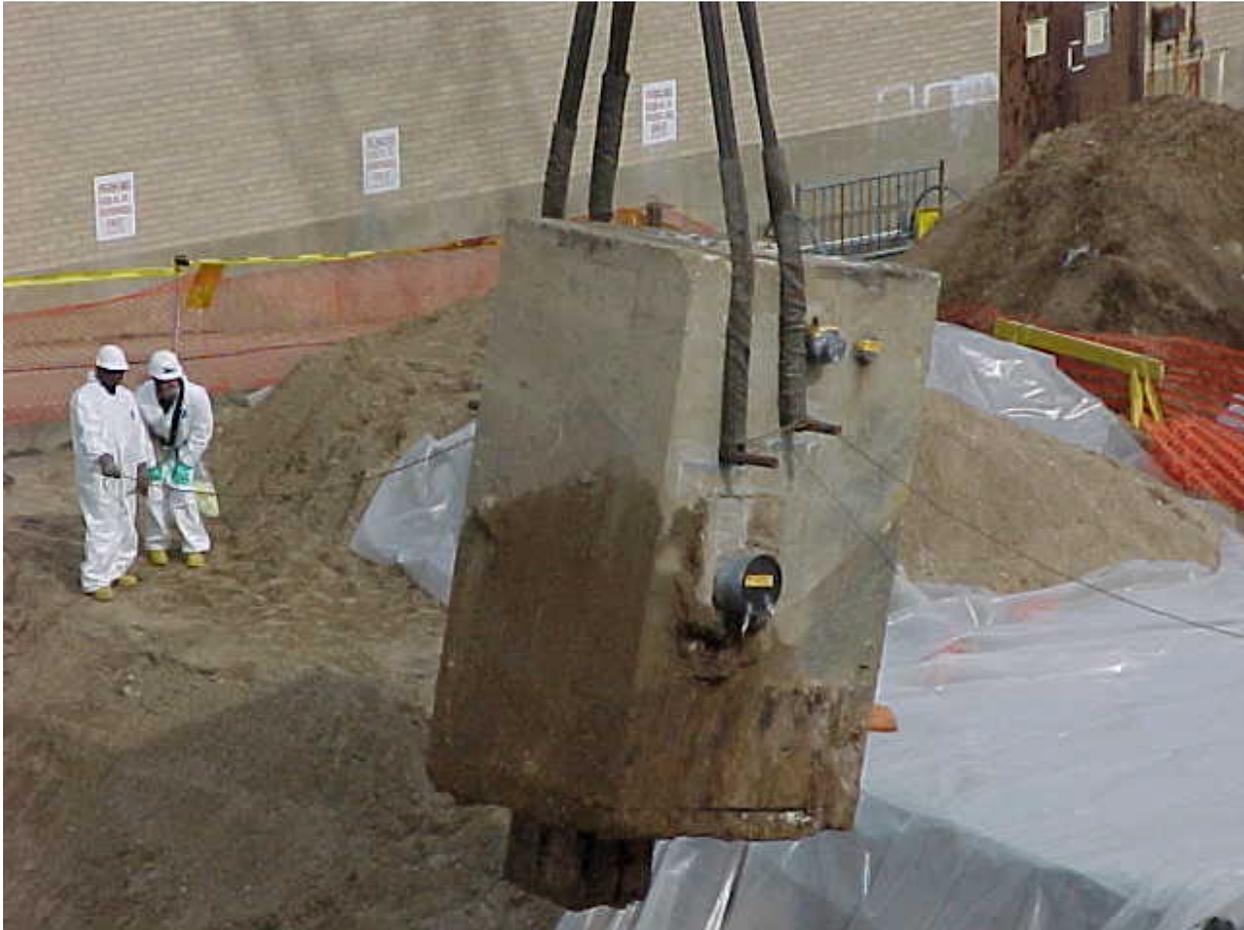
Photo 31. The Pile Fan Sump being lifted. The moist area is from the soils that were around the sump.

Note the sump extension. Cs-137 contamination was found in the soils under this area of the sump.

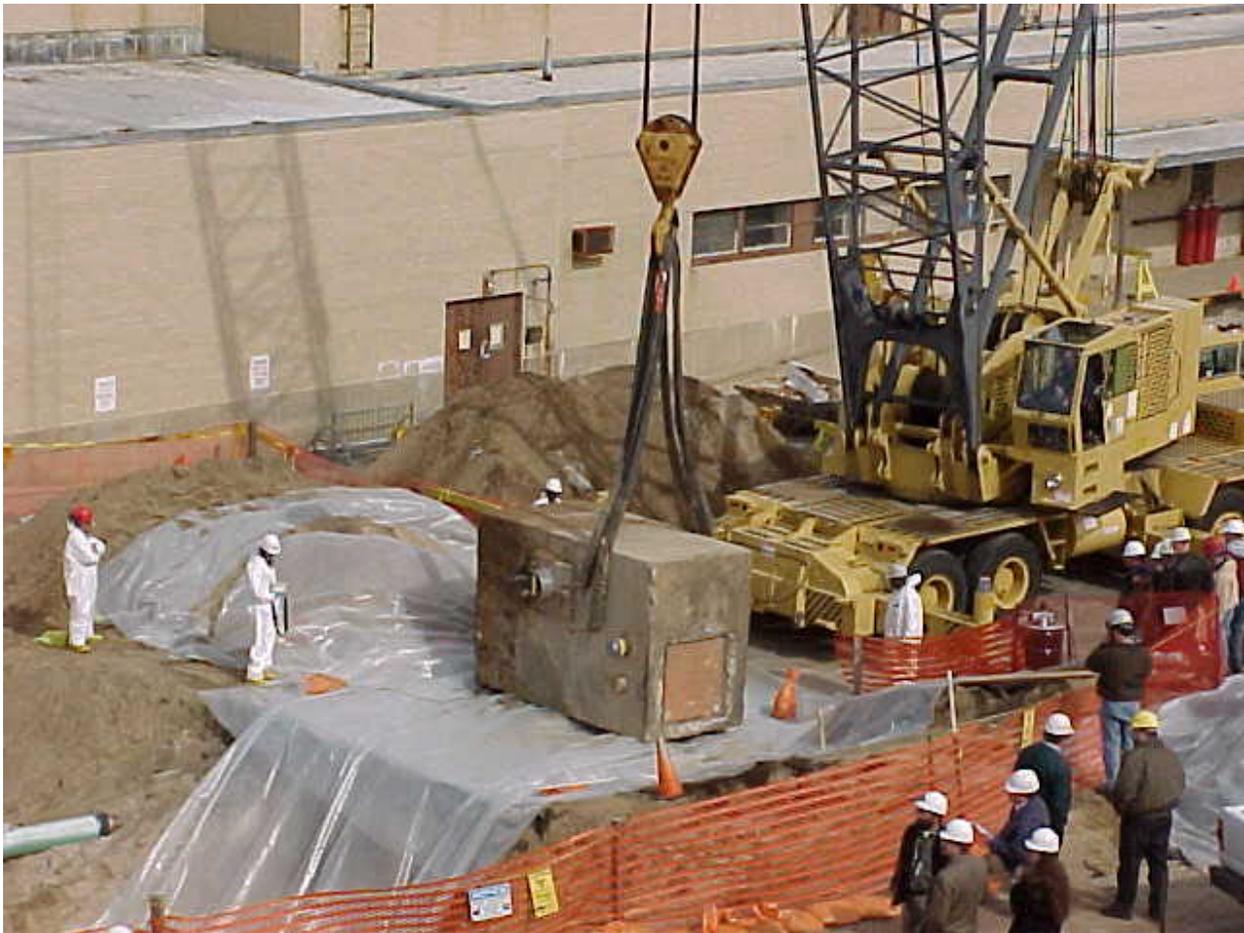
Photo 33. The Pile Fan Sump was placed on its side in the laydown area. The manway was removed and replaced with a plywood cover.

The soils clinging to the bottom of the Pile Fan Sump were found to be contaminated.

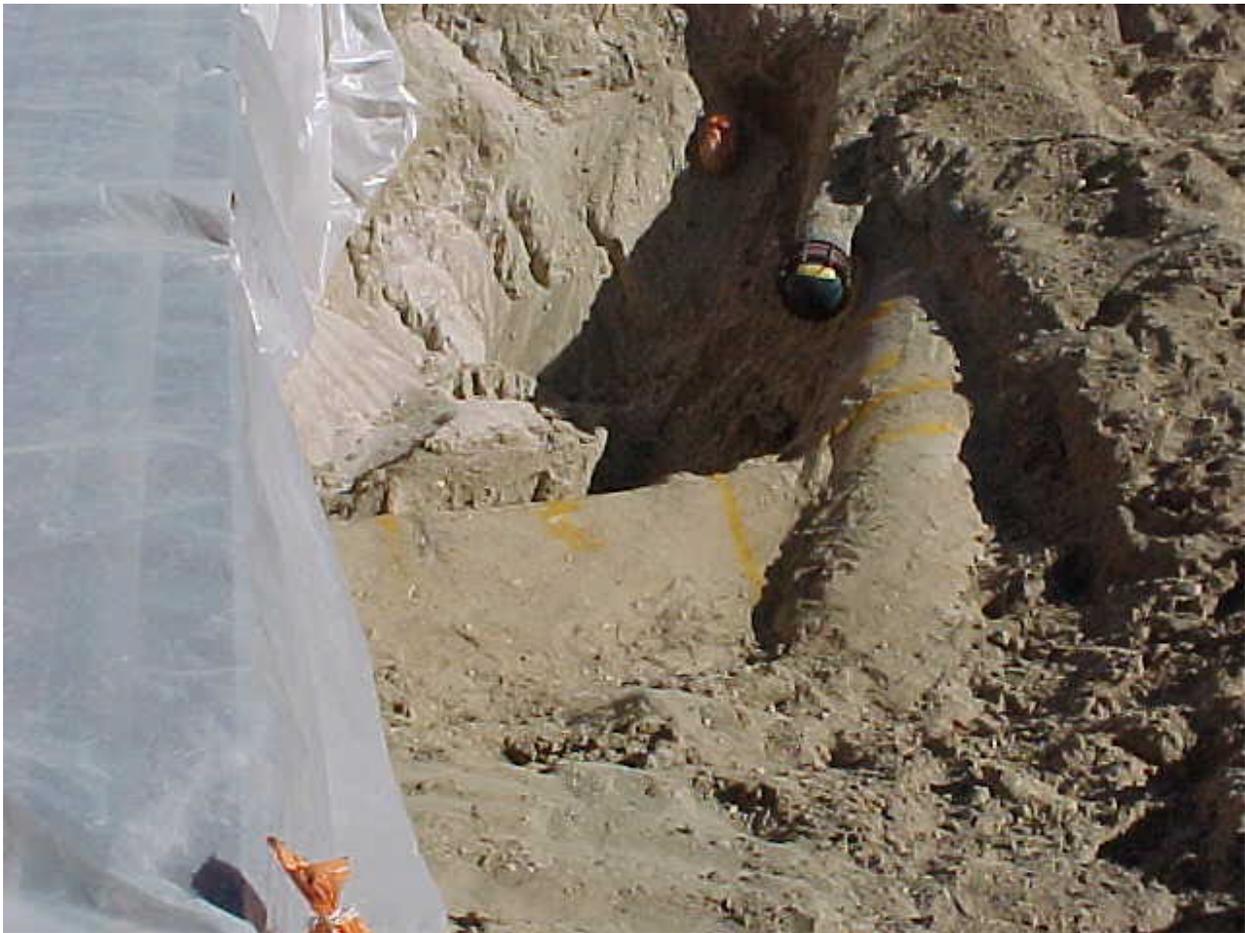
Photo 37. Looking east, area from where the Pile Fan Sump was removed.

Note the 14" line that was capped and the large concrete ventilation line below and to the right.

Note the 24-inch-diameter concrete ventilation line that ties into the large concrete ventilation line.

The bottom of the excavation has Cs-137 contamination. It will be necessary to set a caisson to protect the in service lines from being undermined of soil and collapsing.

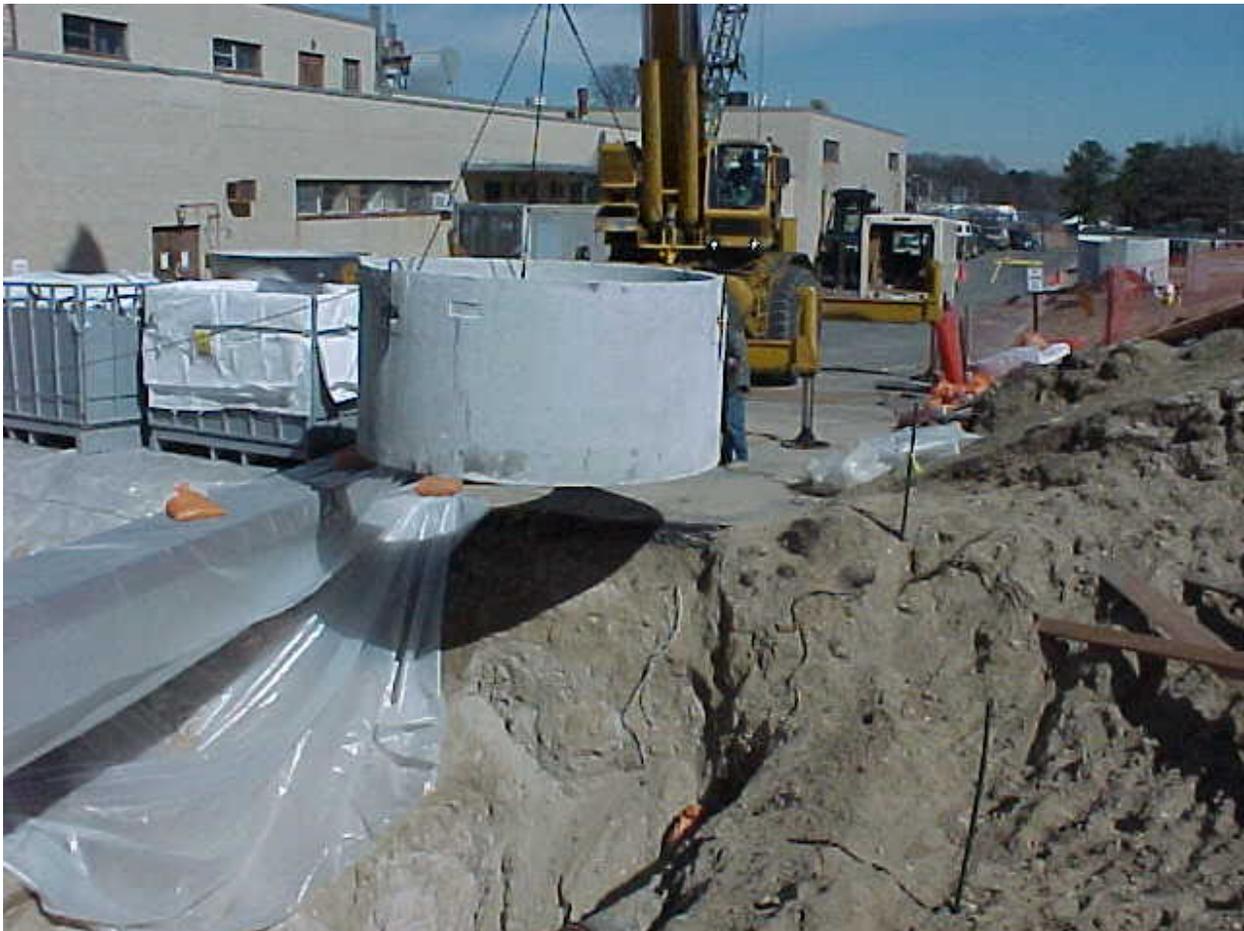
Photo 39. Setting the first caisson in place. Each section of caisson is 10 feet in diameter, 5 feet high.

The size of the caisson was chosen so that the footprint of the Pile Fan Sump would fall inside the circumference of the caisson and permit easier access for soil remediation.

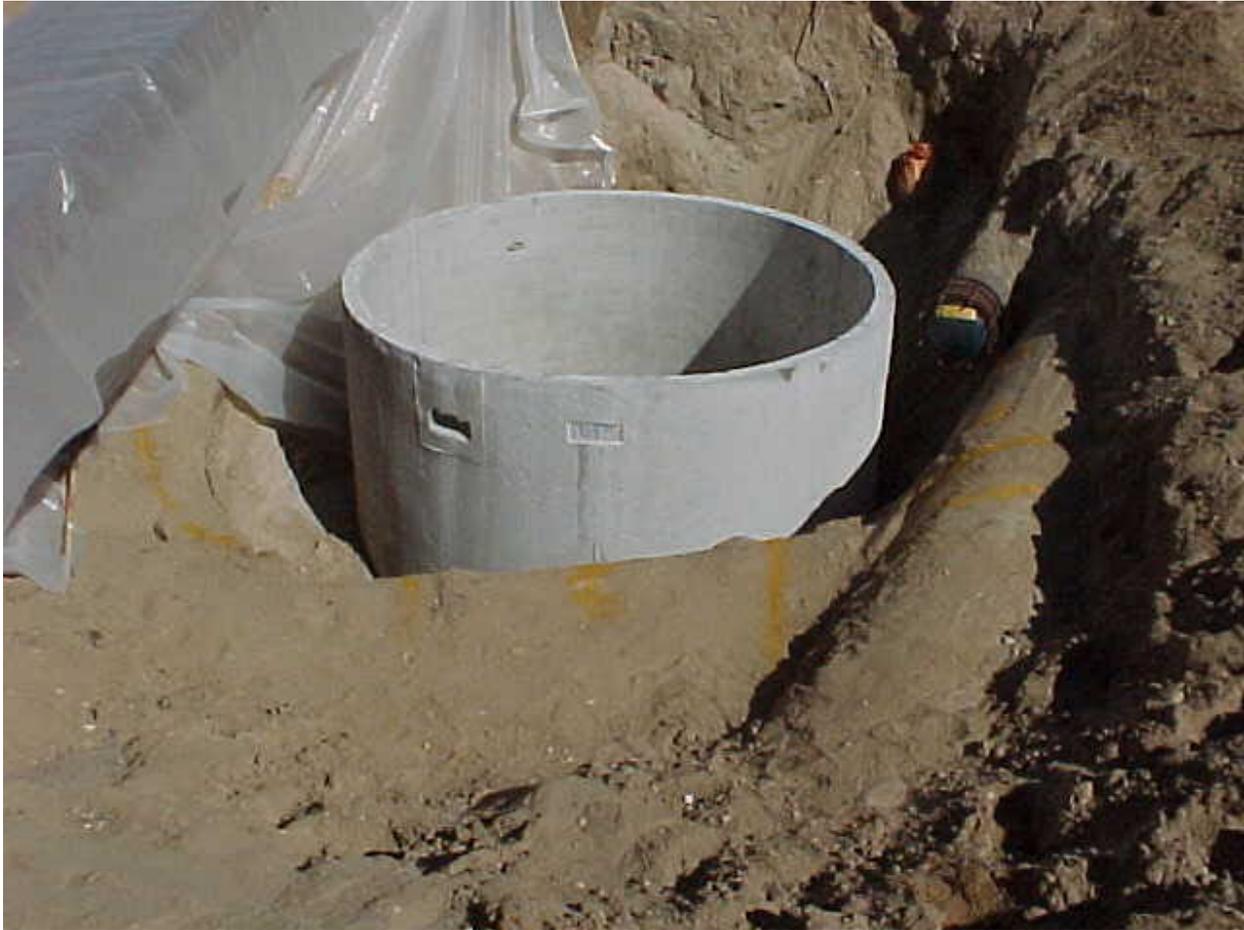
Photo 40. First section of caisson set at approximately 12 feet below grade and near the bottom of the former Pile Fan Sump elevation. Grade is 110 feet above sea level.

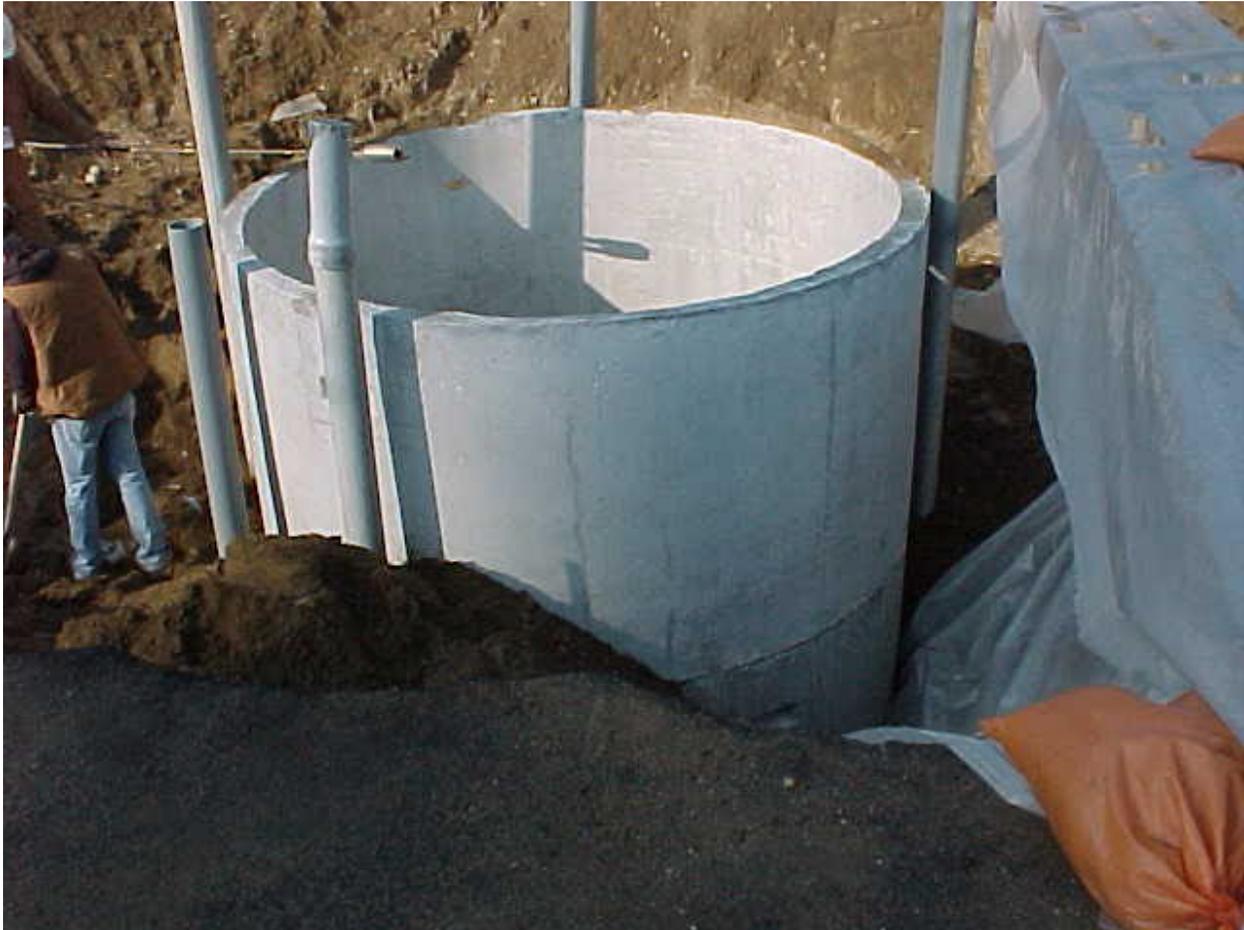
Photo 41. Sample tubes set around the circumference of the caisson where soil sampling was performed to demonstrate that the contamination was bounded by the caisson. Second caisson added. Soil remediation at approximately 17 feet below grade level elevation of 110 feet.

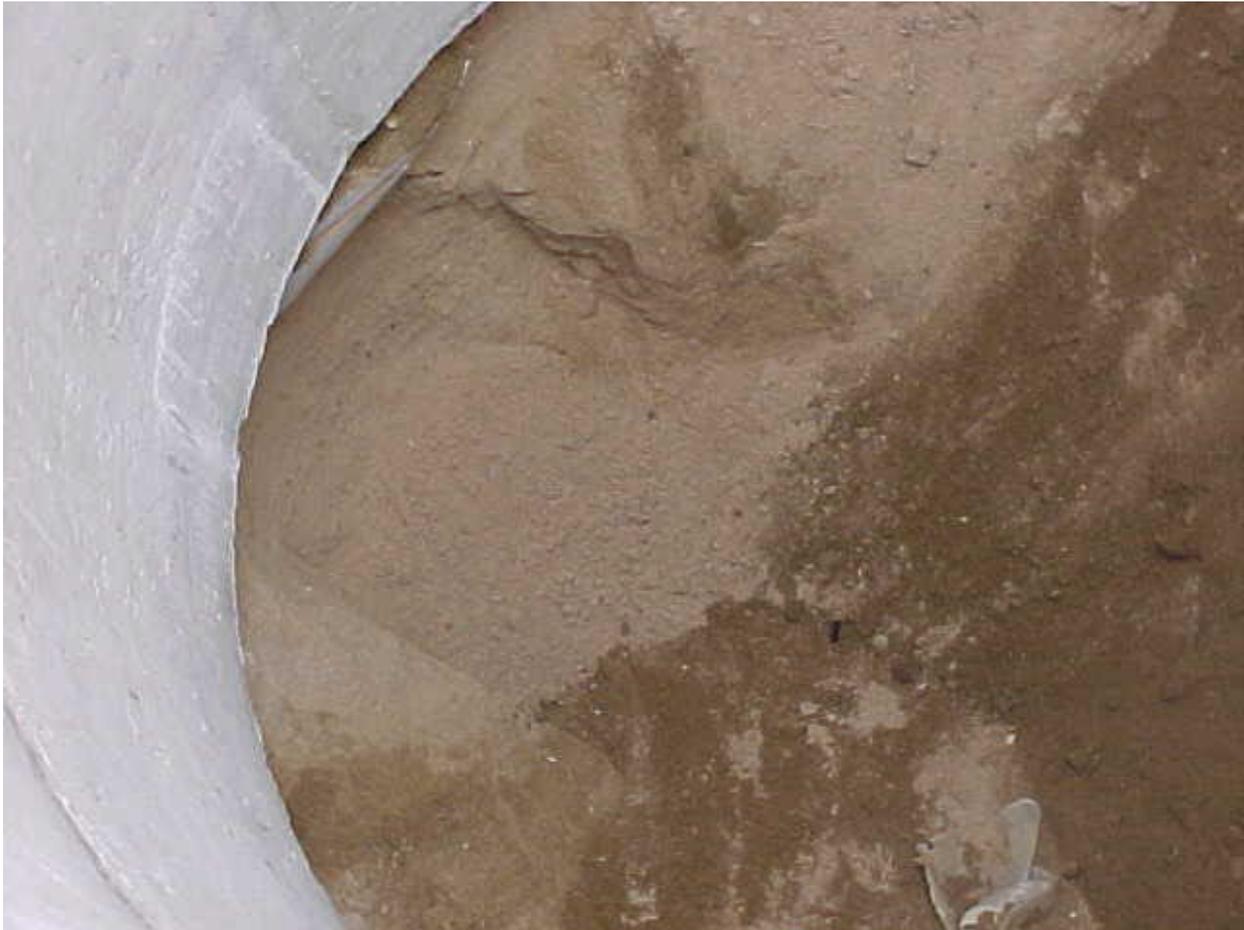
Photo 44. Soil remediation completed in this caisson. However, contamination was found to be in the northeast direction outside the circumference of the caisson. The soils were dug out in the northeast direction and allowed to refill inward. Unable to remediate contaminated soils outside the caisson.
