ATTACHMENT 7

PICTORIAL REVIEW OF THE REMEDIATION ACTIVITY

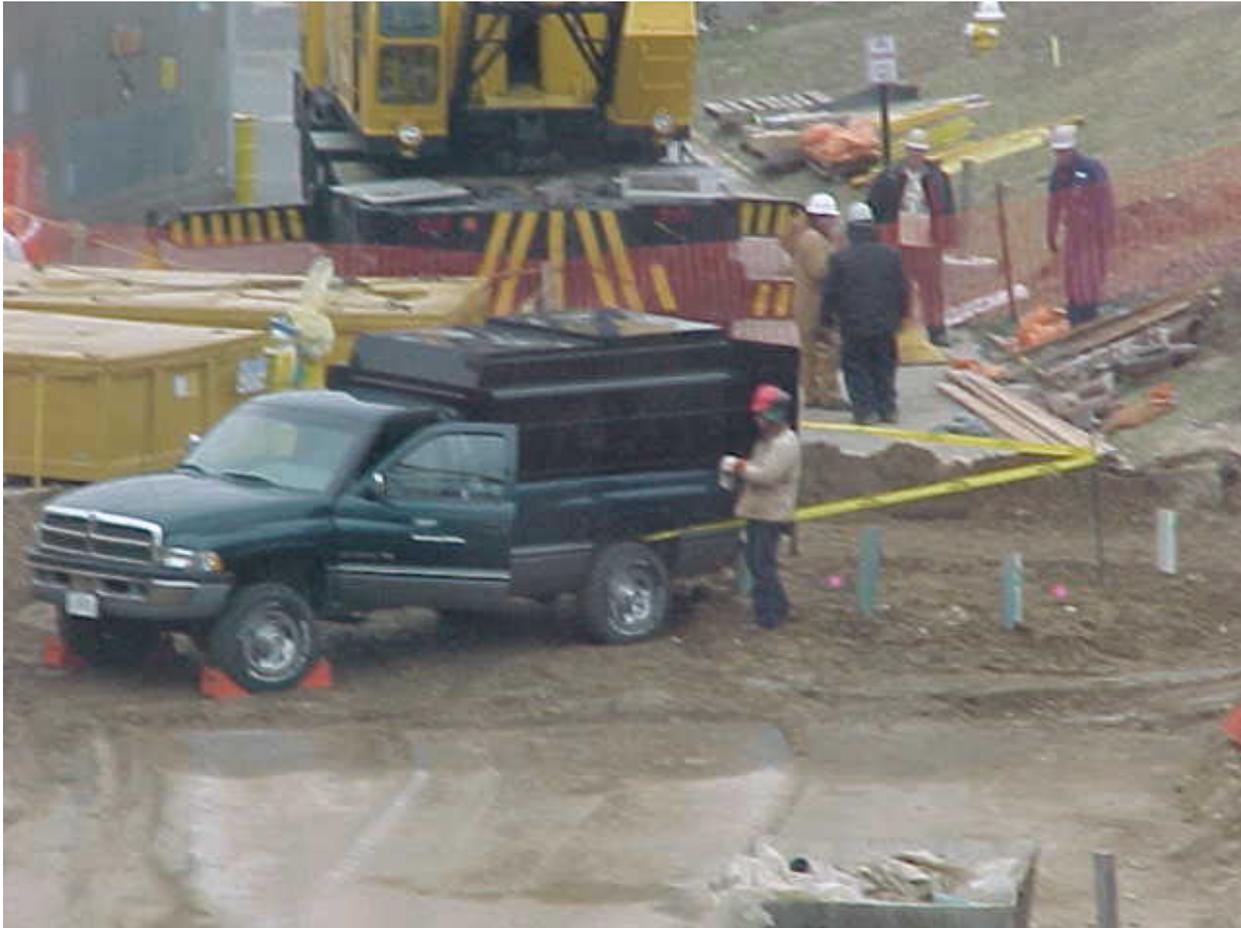
Photo 55. The geoprobe sampling at the second caisson highest measured Cs-137 level. Samples were taken every 10 feet to ground water at 66 feet below grade level elevation of 110 feet, or the approximate elevation 44 feet, groundwater.

Second geoprobe sampling was done at the former location of the extended bottom of the Pile Fan Sump. Samples were taken at 10 feet intervals to a refusal depth of 50 feet below the grade level elevation of 110 feet, or the approximate elevation 60 feet.

The third geoprobe sampling was done at the former location of the 14 inches in diameter piping at the south wall of the Pile Fan Sump. Samples were taken every 10 feet to a depth of 50 feet below the grade level elevation 110 feet, or the approximate elevation 60 feet.

All samples were screened on the field laboratory gamma spectroscopy sampling system. All samples measured at or below typical background levels for Cs-137.
